Rimkus Consulting Group, Inc.
Eight Greenway Plaza, Suite 500
Houston, TX 77046
(800) 580-3228 Telephone
(713) 623-4357 Facsimile

Re: RCG File No: 11009971
LLV Number: 0209452
VMF Location: 1530 Greensmark Drive in Houston, Texas
Subject: Final Report

Rimkus Consulting Group, Inc. was retained to examine LLV 0209452, VIN 1GBCS10E4M2908832. The fire occurred on June 13, 2016 at around 12:30 P.M. the operator of the vehicle at the time of the fire, was unavailable for interview but reportedly stated the vehicle's engine died while delivering mail on his route and backfired during subsequent attempts to restart it. Soon thereafter, smoke was observed from beneath the hood as well as flames.

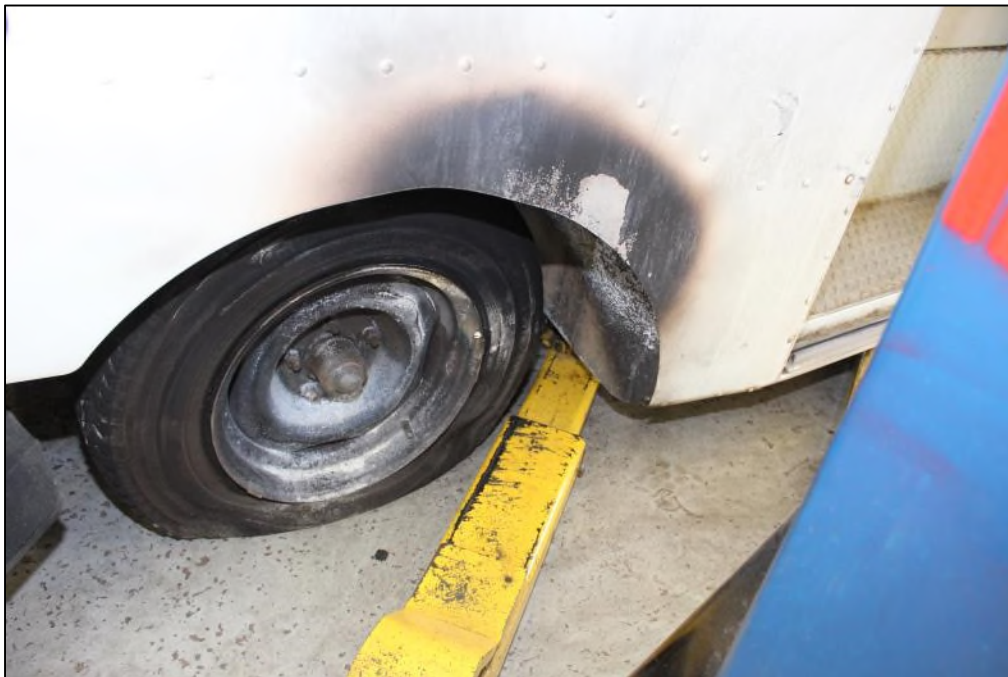
Photograph 4

Fire damage to the left front wheel-well and tire.

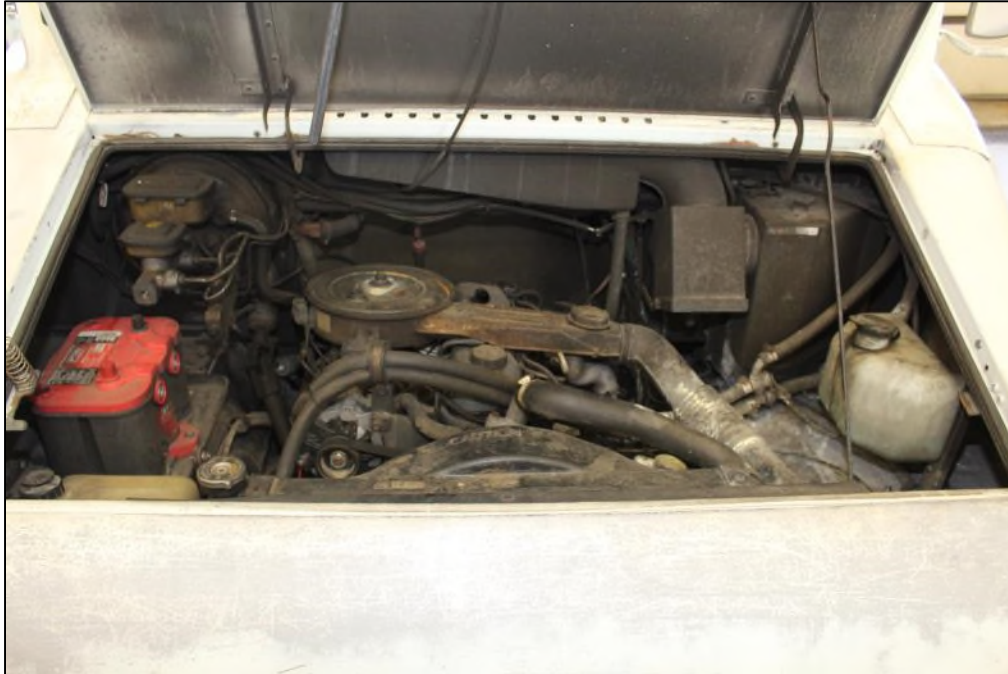
Photograph 5

Engine compartment of the vehicle.

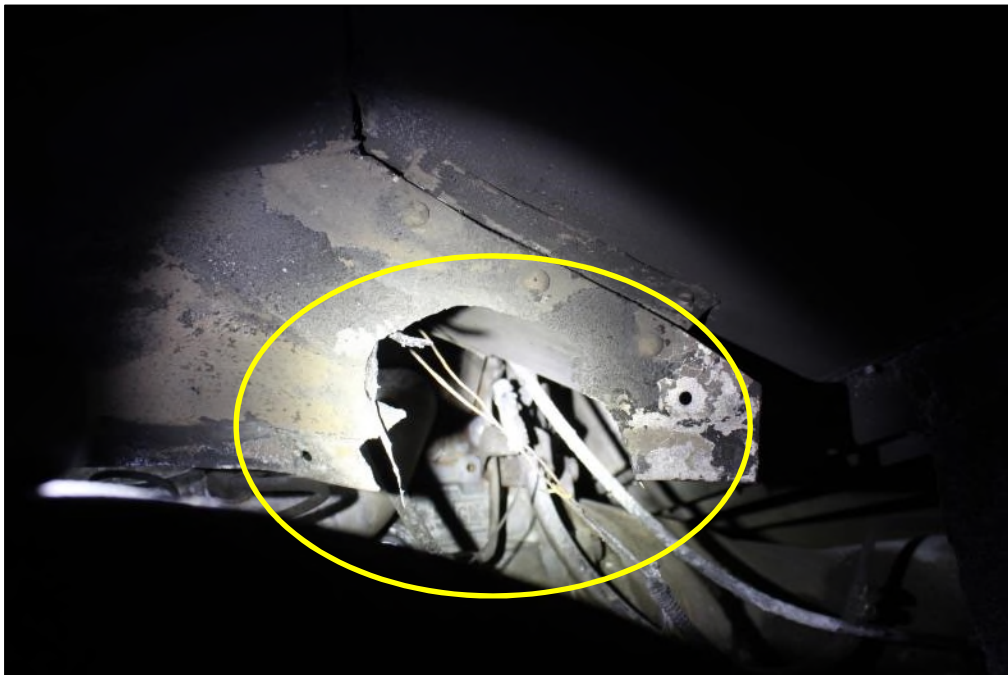
Photograph 6

Localized damage in the wheel-well and engine compartment.

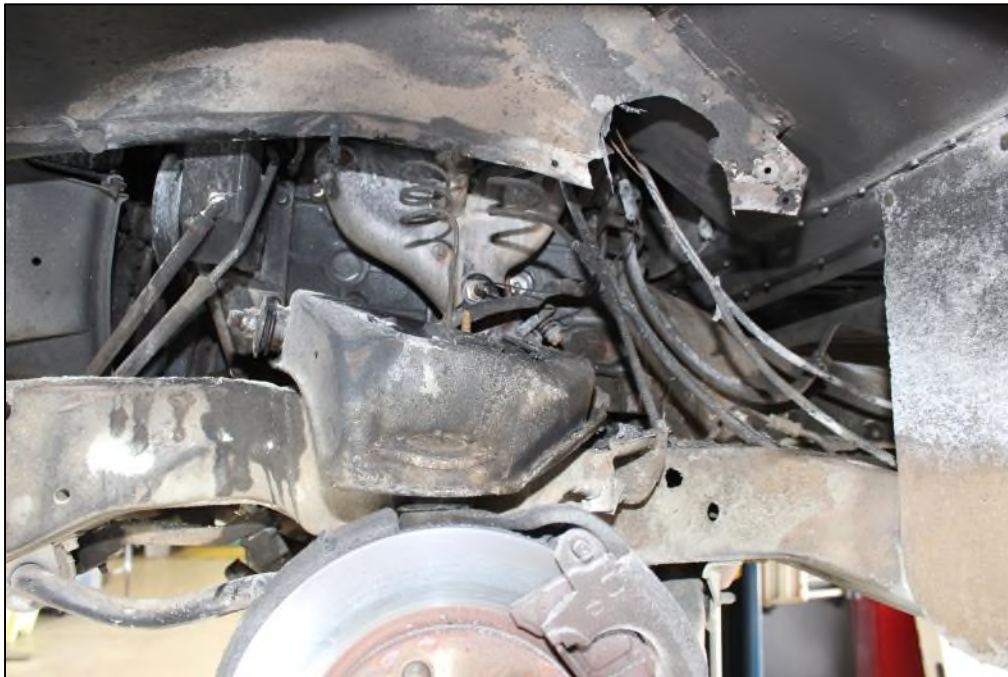
Photograph 7

Fire damage in the wheel-well and lower, left-side of the engine compartment.

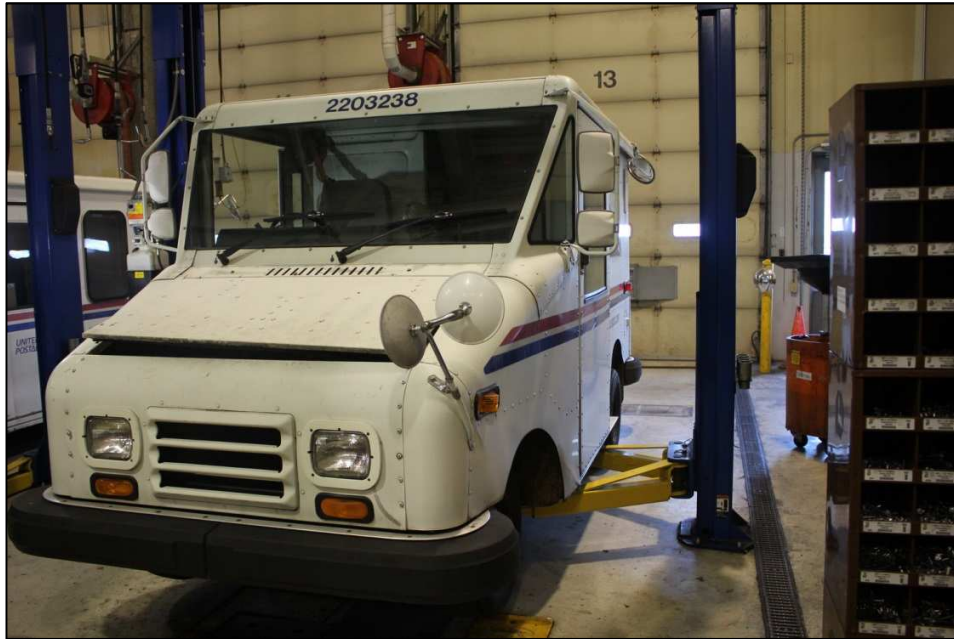
Photograph 1

View of the exterior of the USPS LLV 2203238.

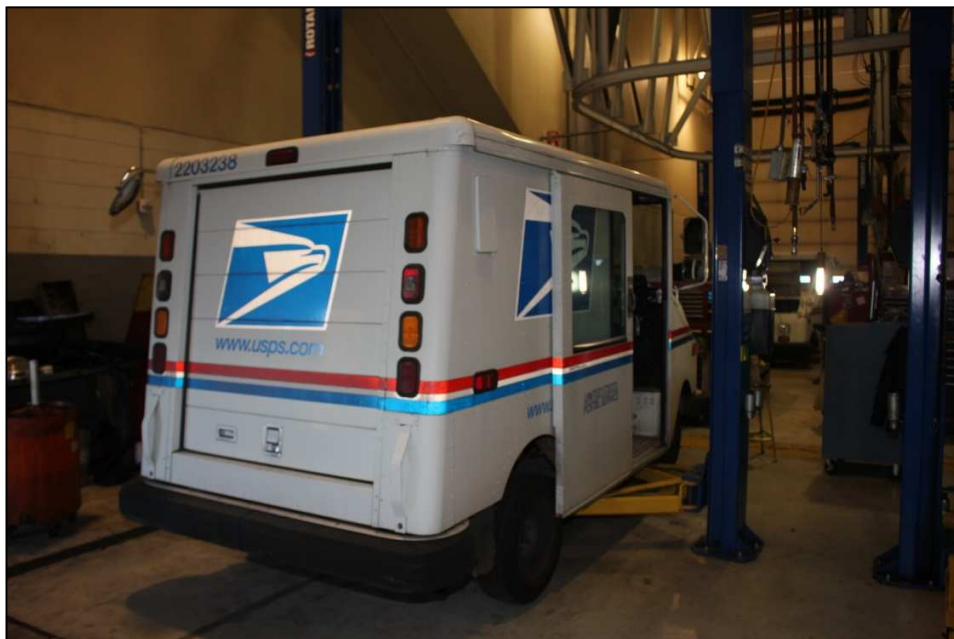
Photograph 2

View of the exterior of the USPS LLV 2203238.

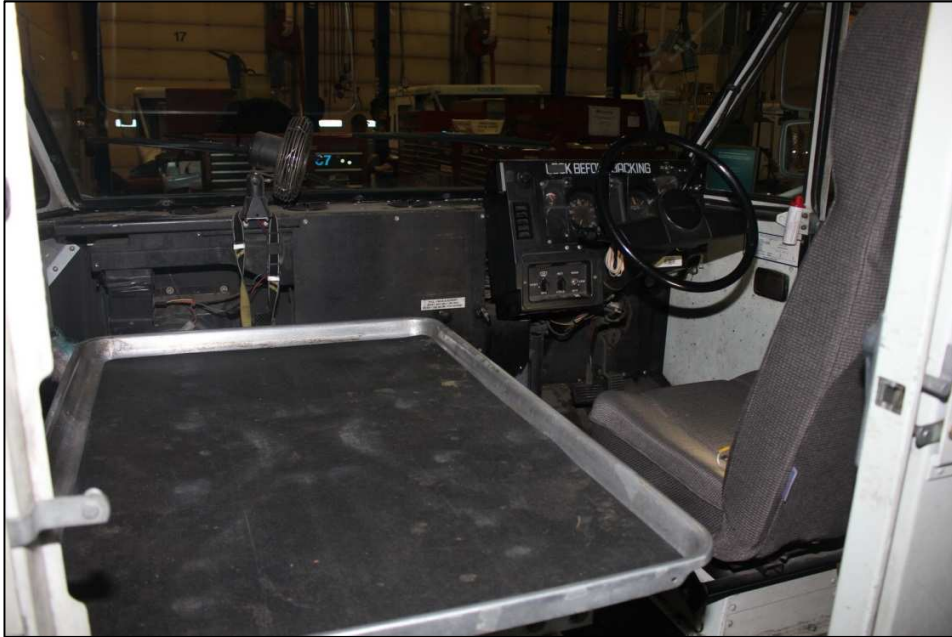
Photograph 3

The interior examination of the vehicle, including the operator's and cargo compartments revealed no observable physical evidence of soot, smoke, heat or fire damage.

View of the operator's compartment of the USPS LLV 2203238.

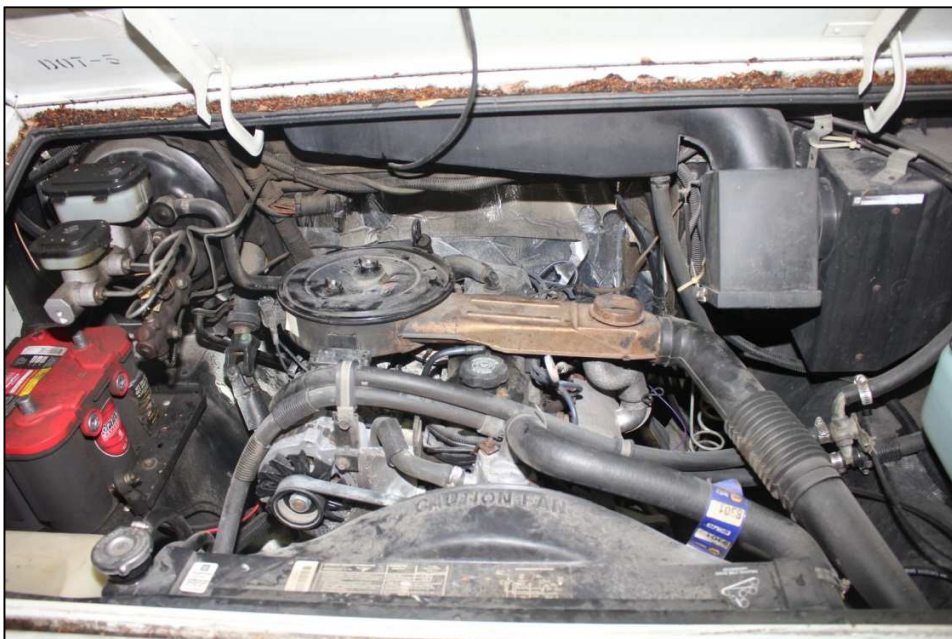
Photograph 4

The examination of the engine compartment revealed no observable physical evidence of soot, smoke, heat or fire damage. The 1992 GMC LLV 2203238 was powered by an inline mounted throttle body gasoline-fuel injected, four cylinder engine with rear wheel drive and an automatic transmission. We inspected the radiator, radiator shroud, air intake system, Carter fuel filter system, fuel lines, belts, hoses, battery, battery cables insulation, battery box, electrical wiring, engine compartment wiring harness, master cylinder, and all plastic components within the upper engine compartment which sustained no noticeable fire-related damage. The engine compartment showed no evidence of oil leakage although the engine dipstick indicated the oil level was low. The engine block, heads, exhaust manifold, alternator, brake booster, transmission, inner fenders and remaining noncombustible components also sustained no noticeable fire related damage. The vehicle was equipped with a GM fuel filter system.

View of the engine compartment of the USPS LLV 2203238.

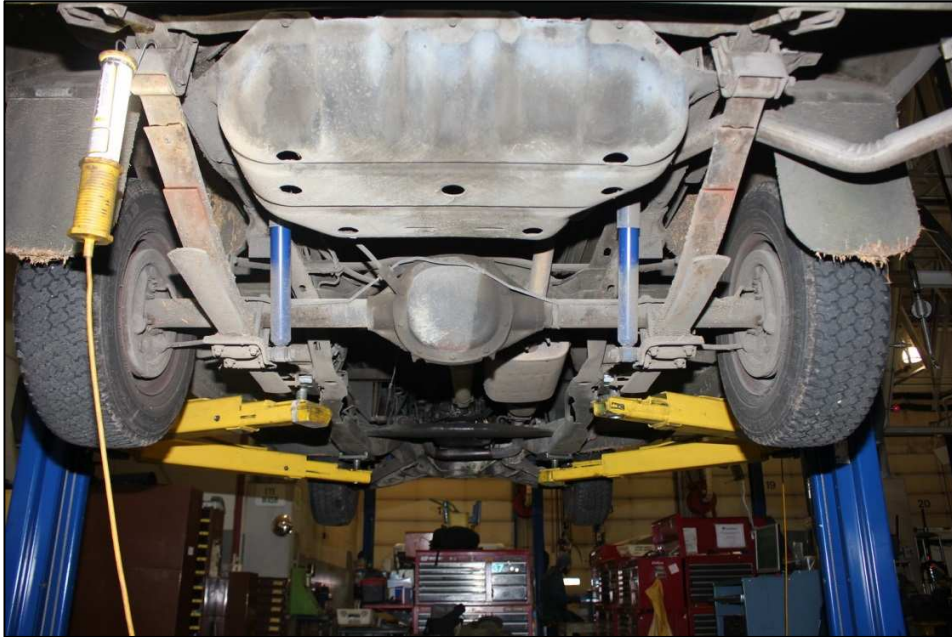
Photograph 5

Examination of the undercarriage revealed no observable physical evidence of soot, smoke, heat or fire damage. The involved LLV was mounted on a GM frame.

View of the rear under carriage and frame system of the USPS LLV 2203238.

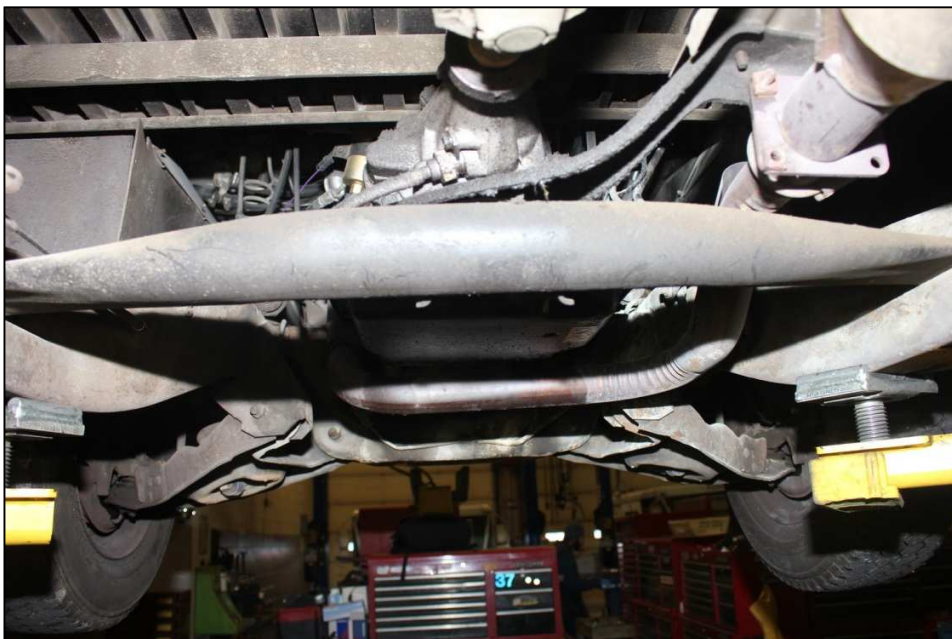
Photograph 6

View of the front under carriage, and frame system of the USPS LLV 2203238.

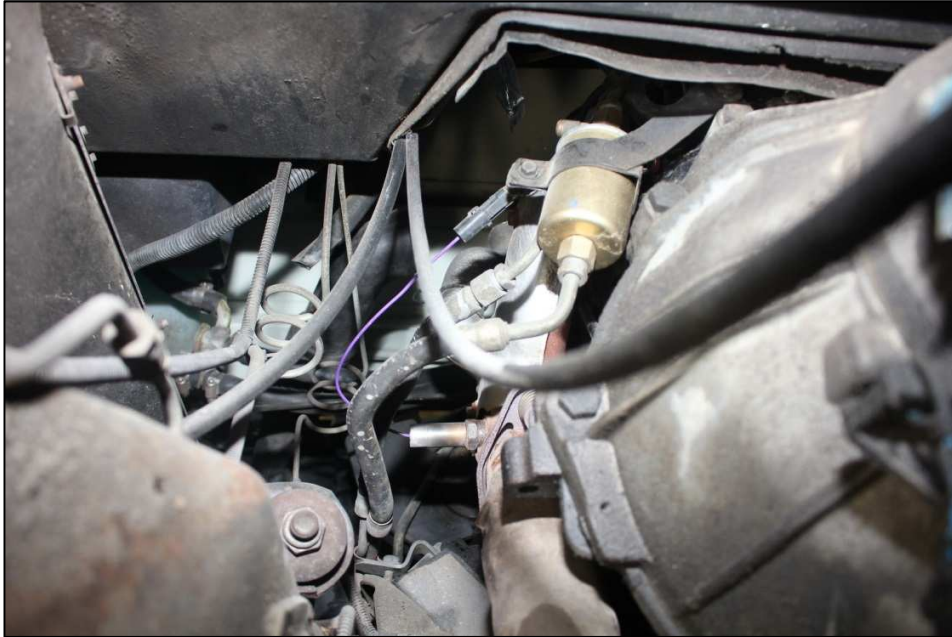
Photograph 7

View of the fuel lines and fuel filter system of the USPS LLV 2203238.

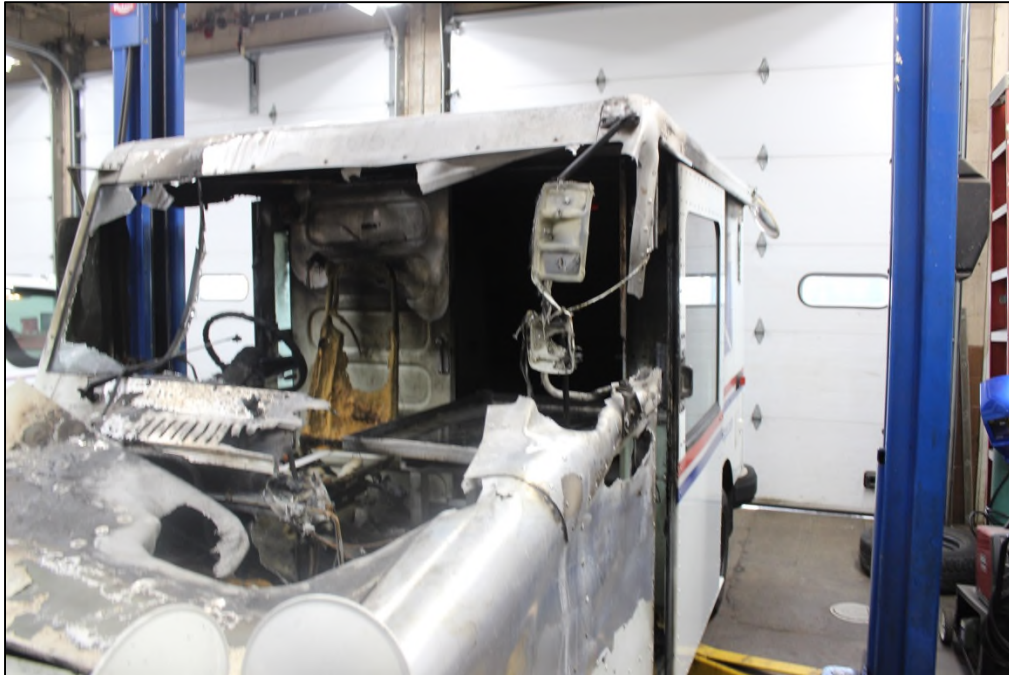
Photograph 1

Left front with fire damage to hood, roof, mirrors, and A post of body.

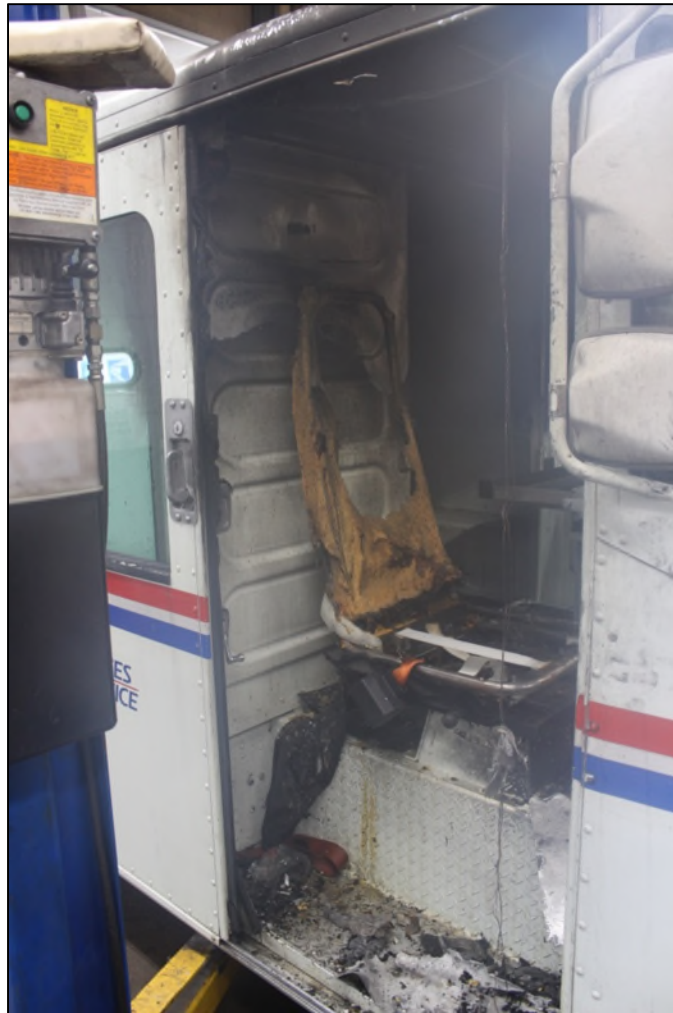
Photograph 2

Driver / right side of vehicle with heavy fire damage to interior.

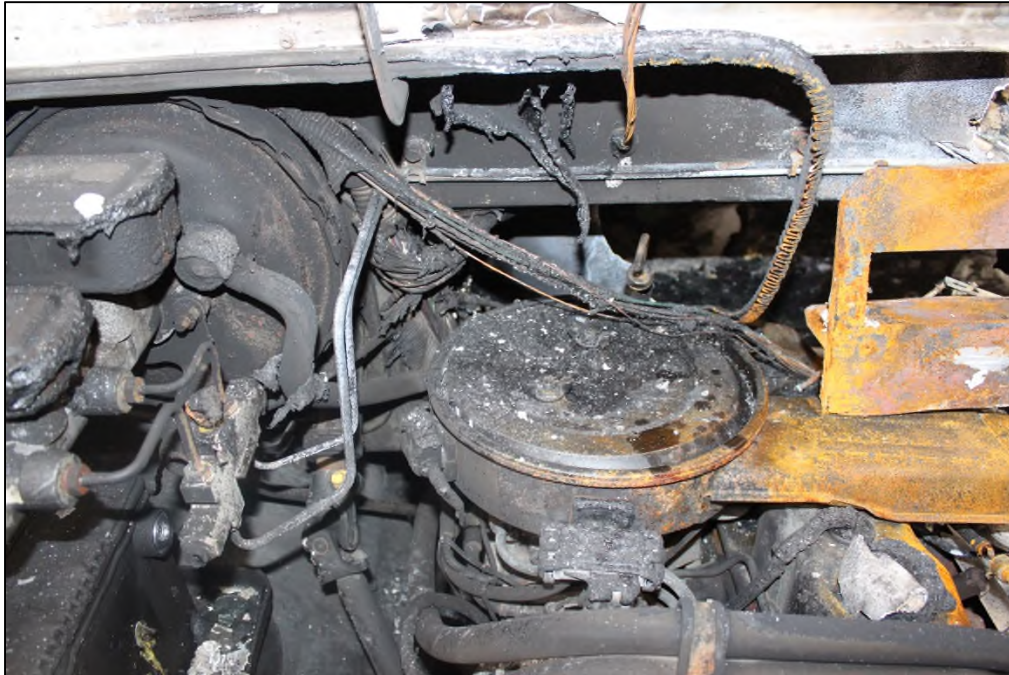
Photograph 3

Engine compartment with radiant heat damage extending from the left rear.

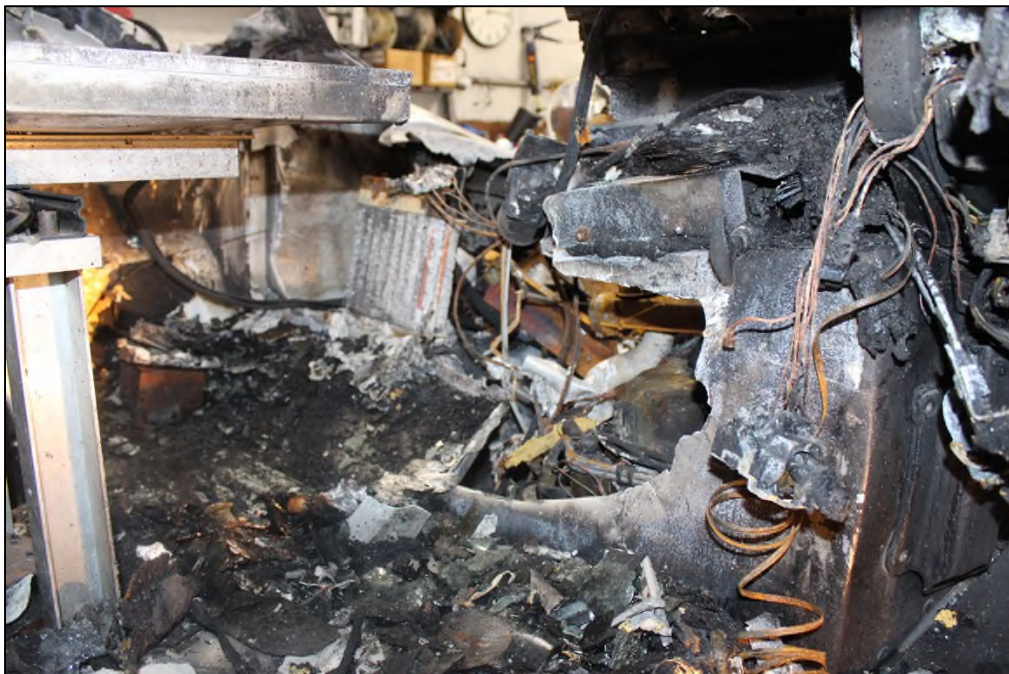
Photograph 4

Area of fire origin at the left front dash heater blower motor location.

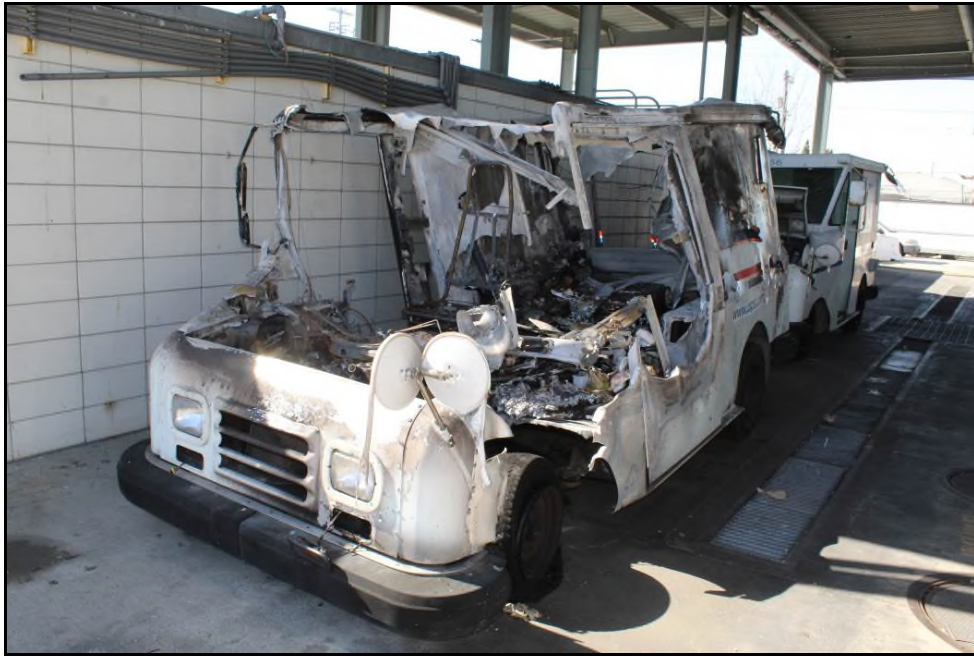
Photograph 1
Subject LLV.

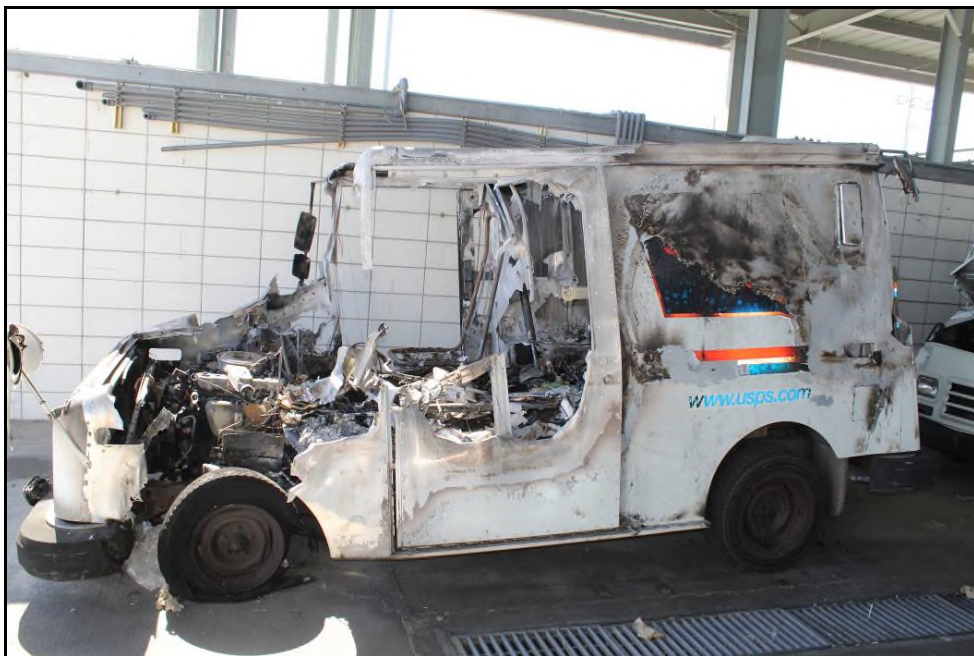
Photograph 2
Subject LLV, left side.

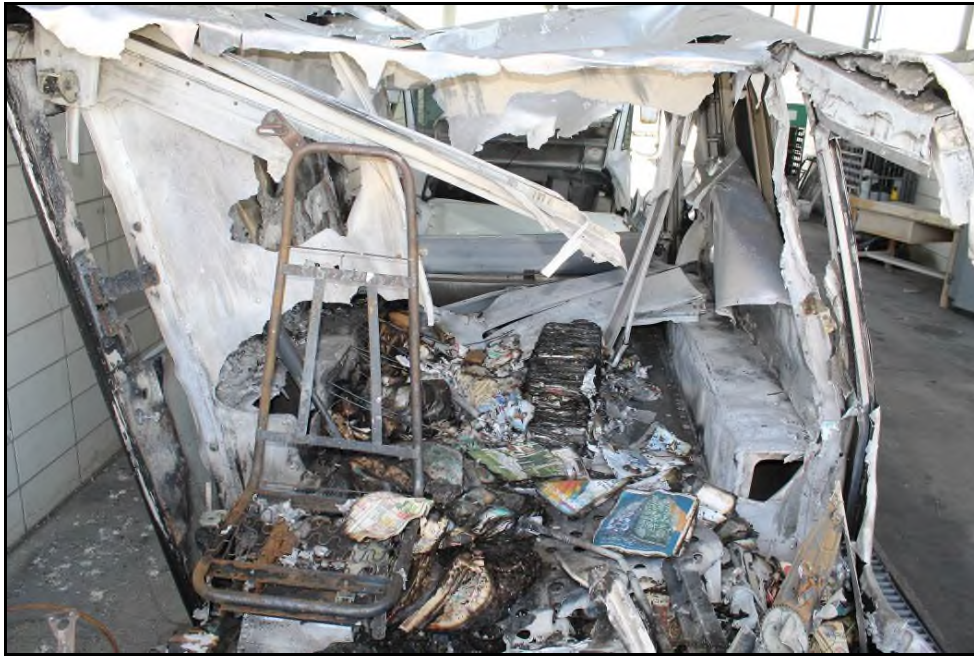
Photograph 3
Interior and cargo areas.

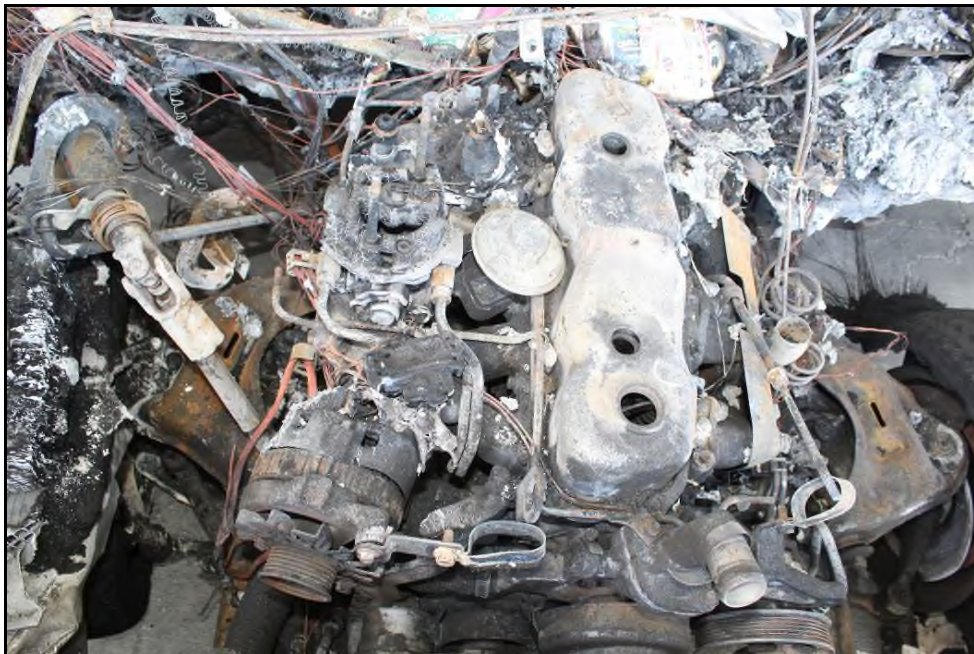
Photograph 4
Engine, Air filter removed for inspection.

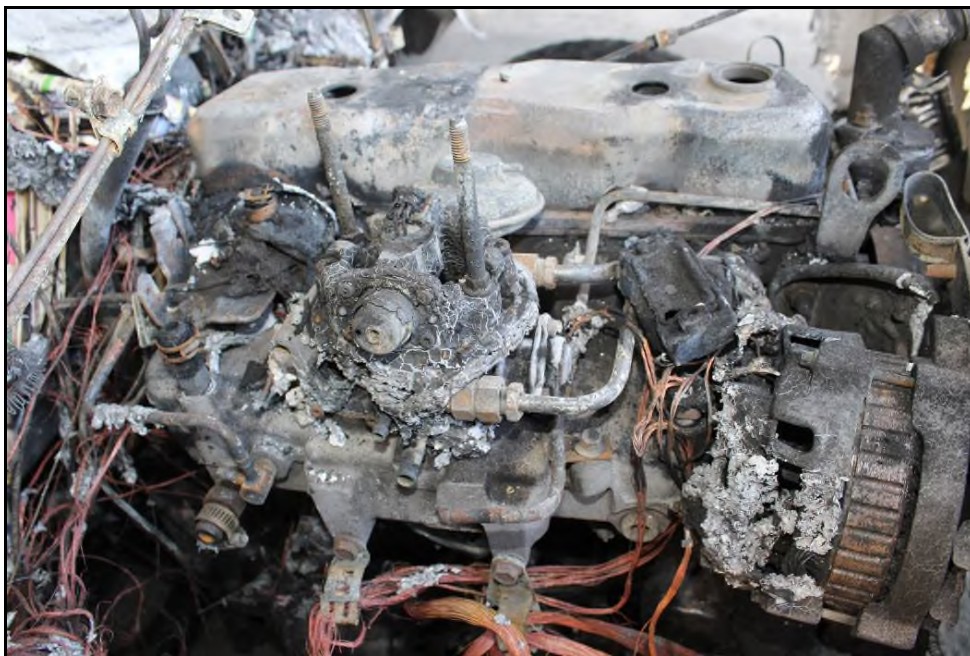
Photograph 5
Engine, right side.

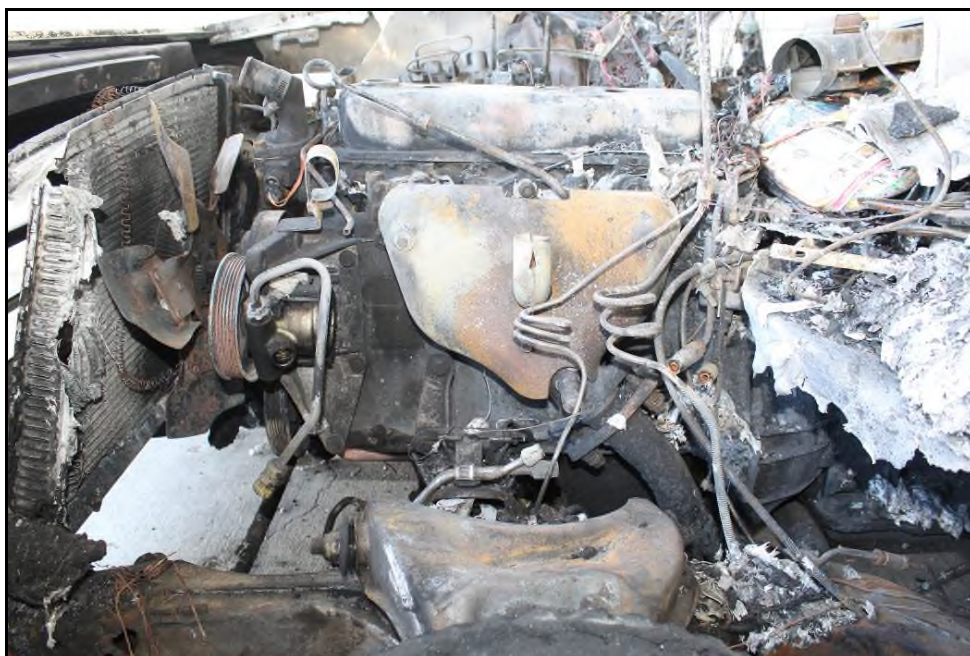
Photograph 6
Engine, left side.

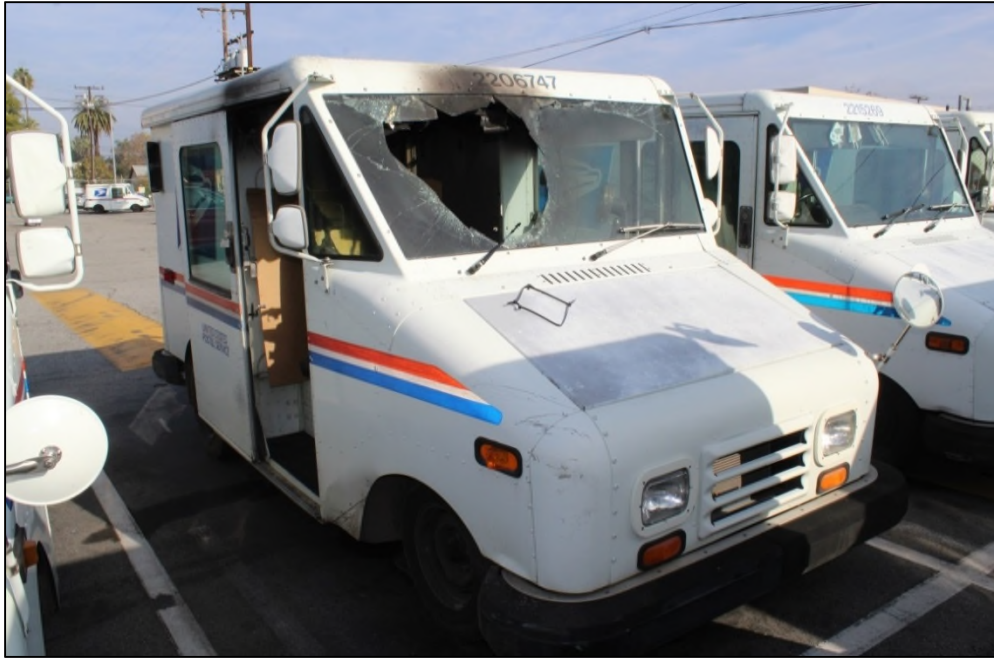
Photograph 1
Subject LLV 2206747.

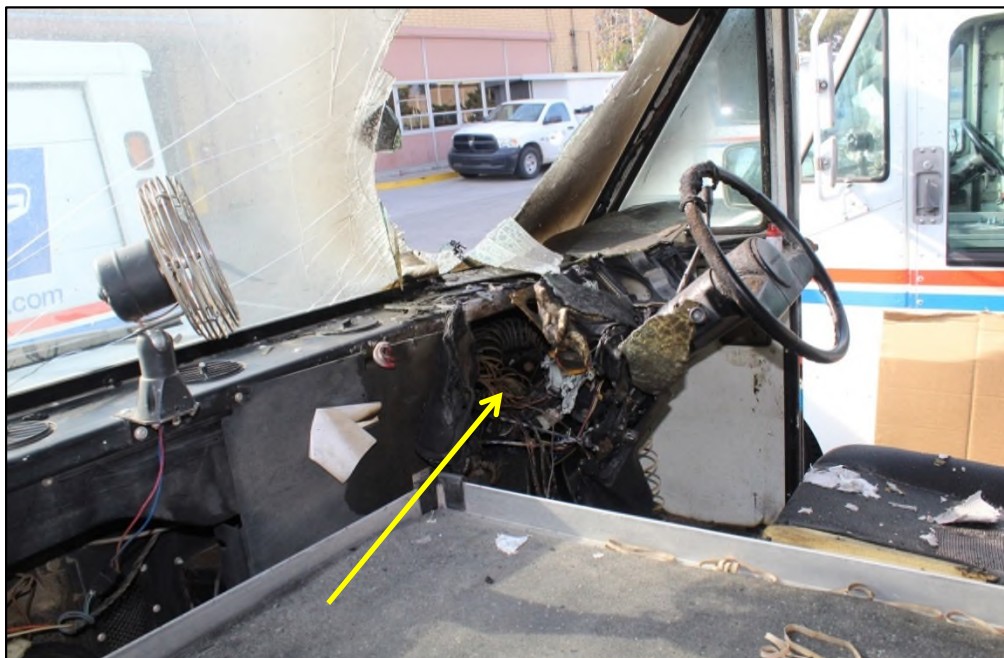
Photograph 2
Fire origin in dashboard, yellow arrow.

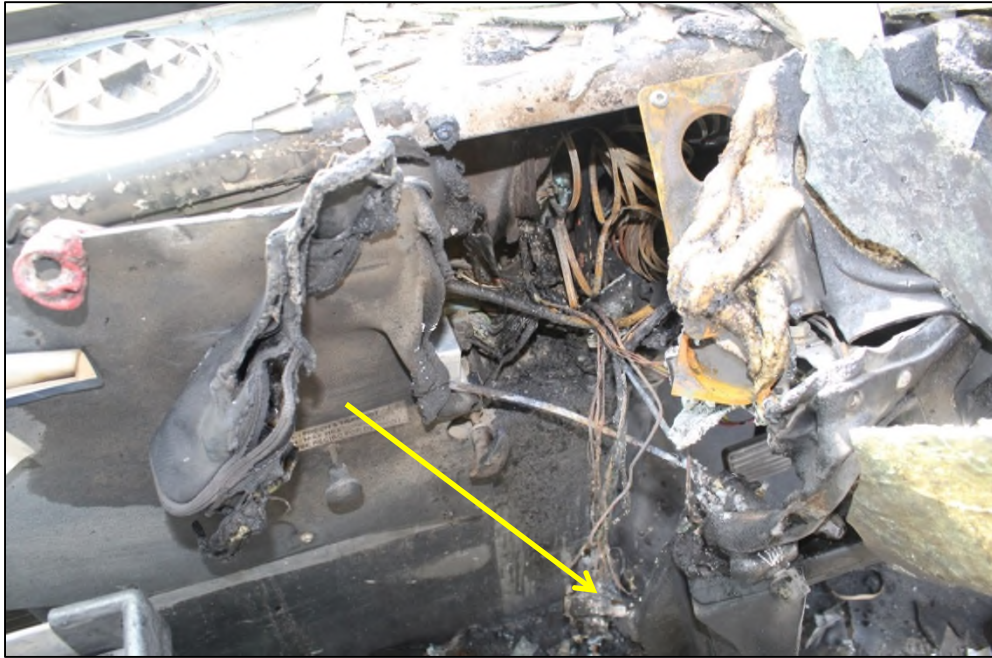
Photograph 3

Fire origin in dashboard, center. Headlight switch mechanism, yellow arrow.

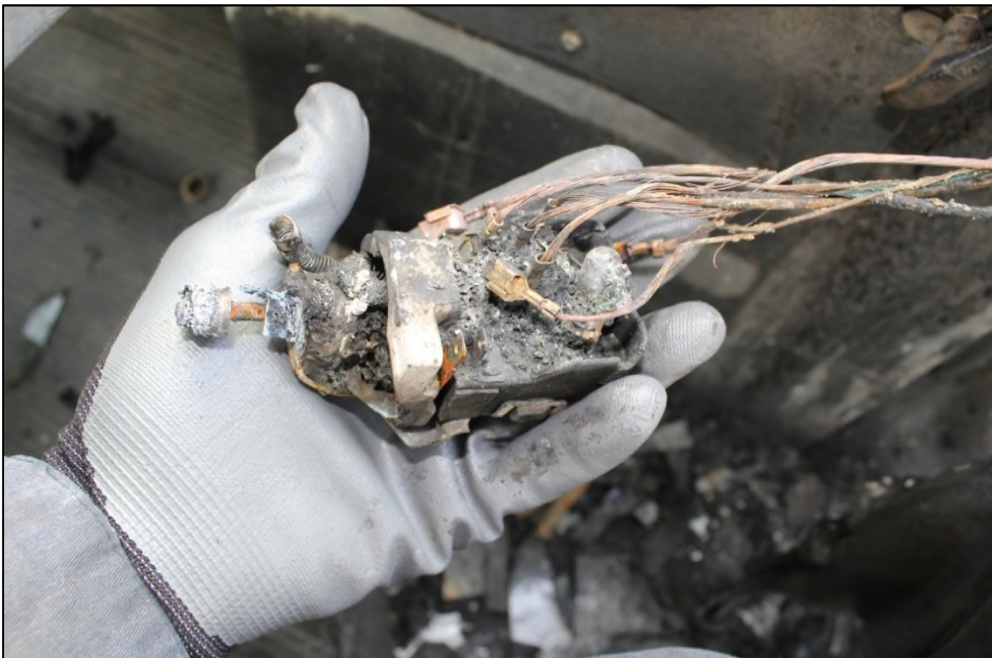
Photograph 4

Headlight switch mechanism.

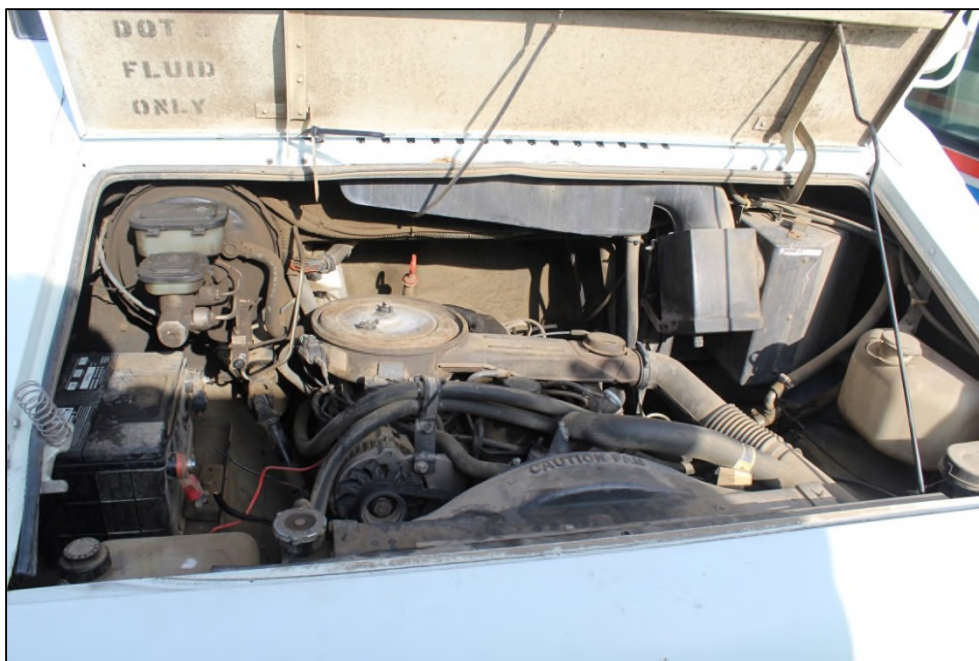
Photograph 5
The engine compartment.

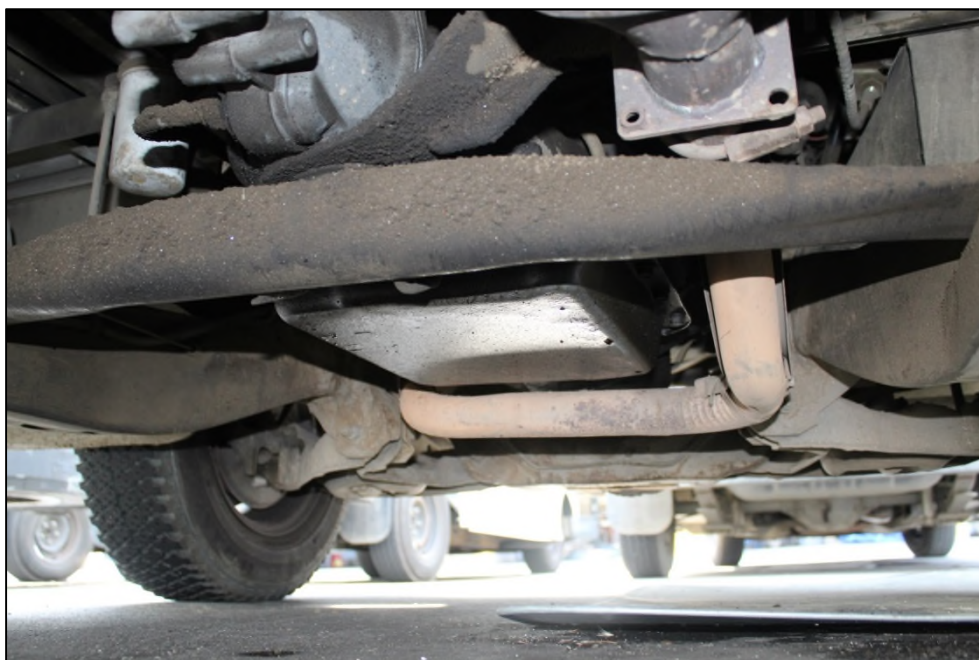
Photograph 6
The undercarriage.

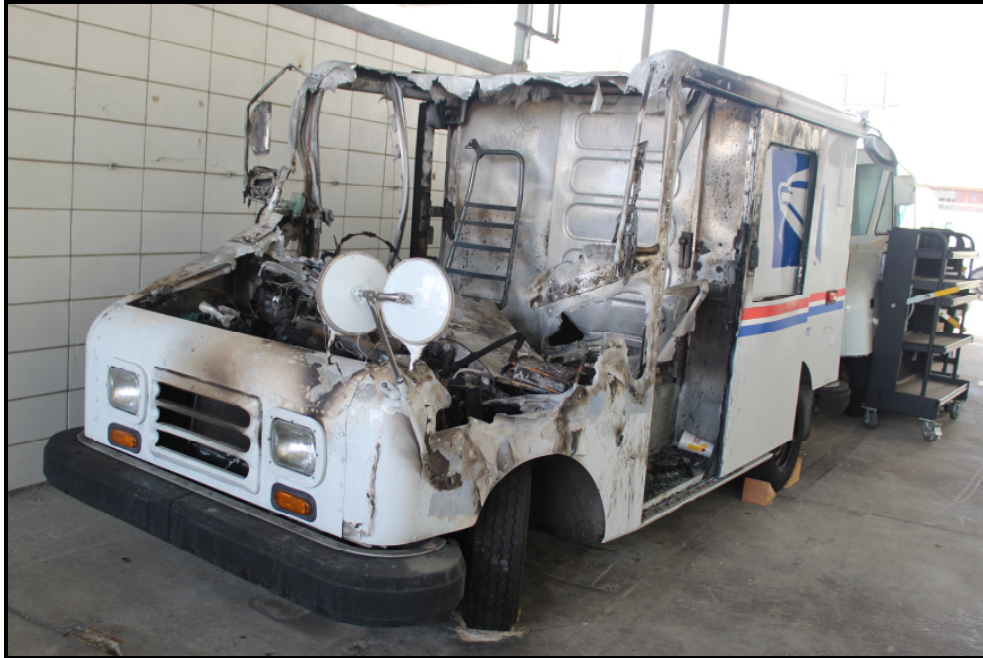
Photograph 1

Severe fire damage to the engine compartment on the mail side.

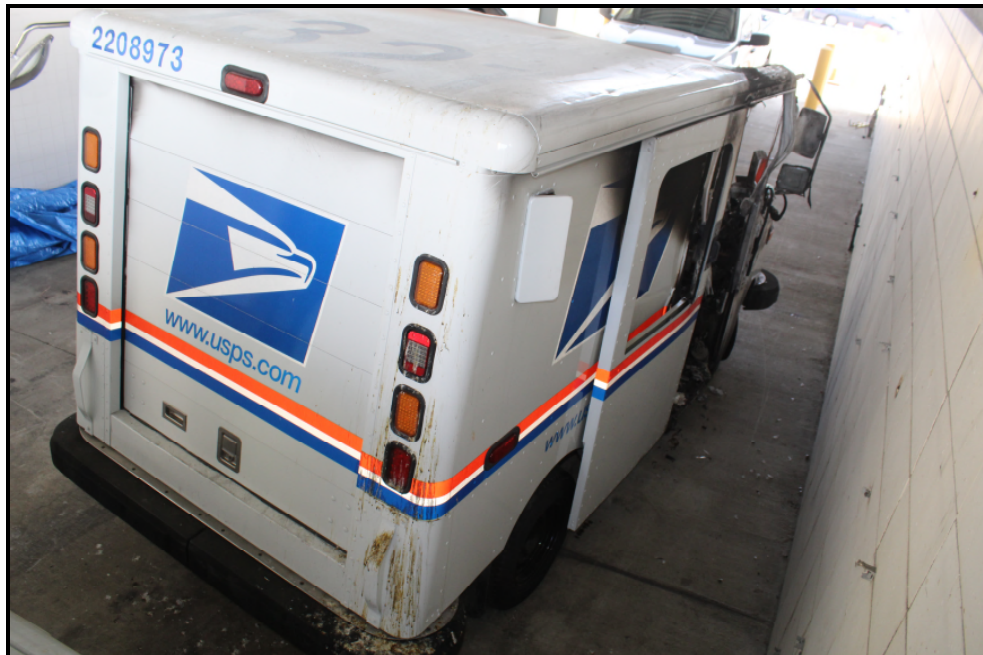
Photograph 2

The rear of the vehicle, no fire damage.

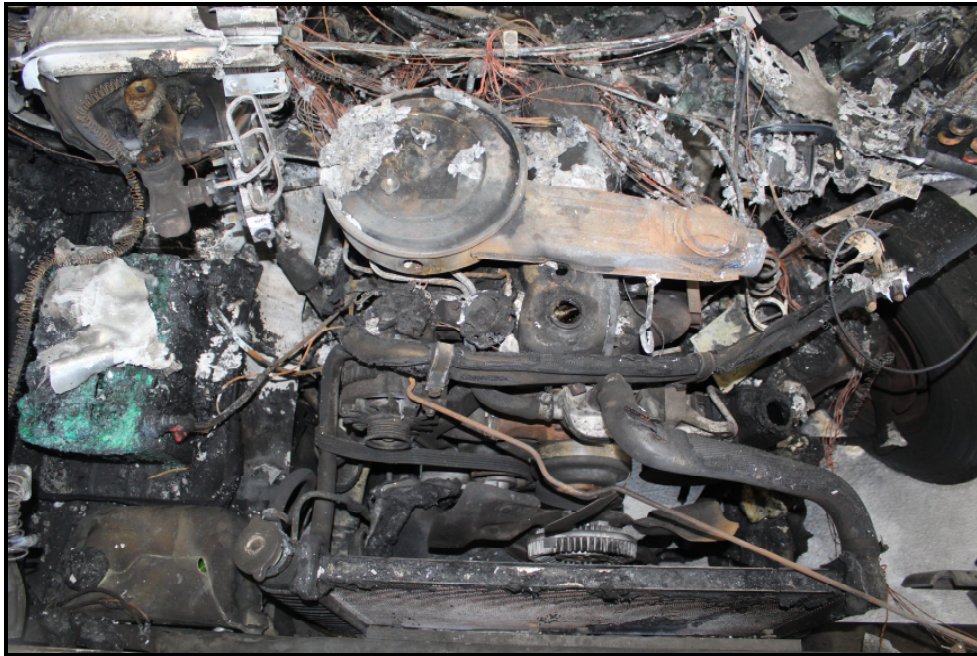
Photograph 3
Engine compartment.

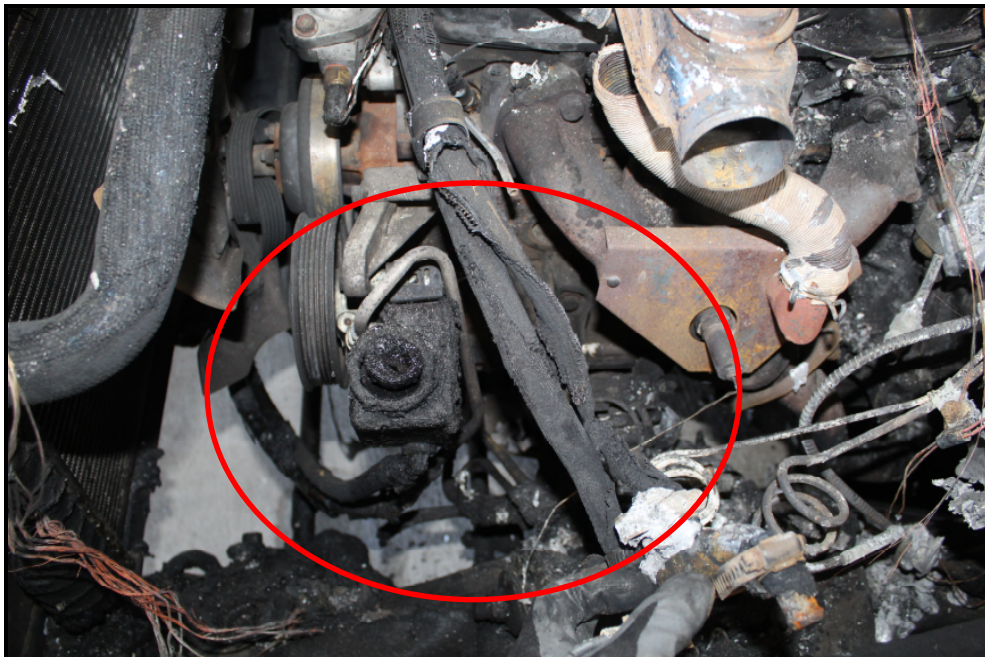
Photograph 4
Power steering Pump and components.

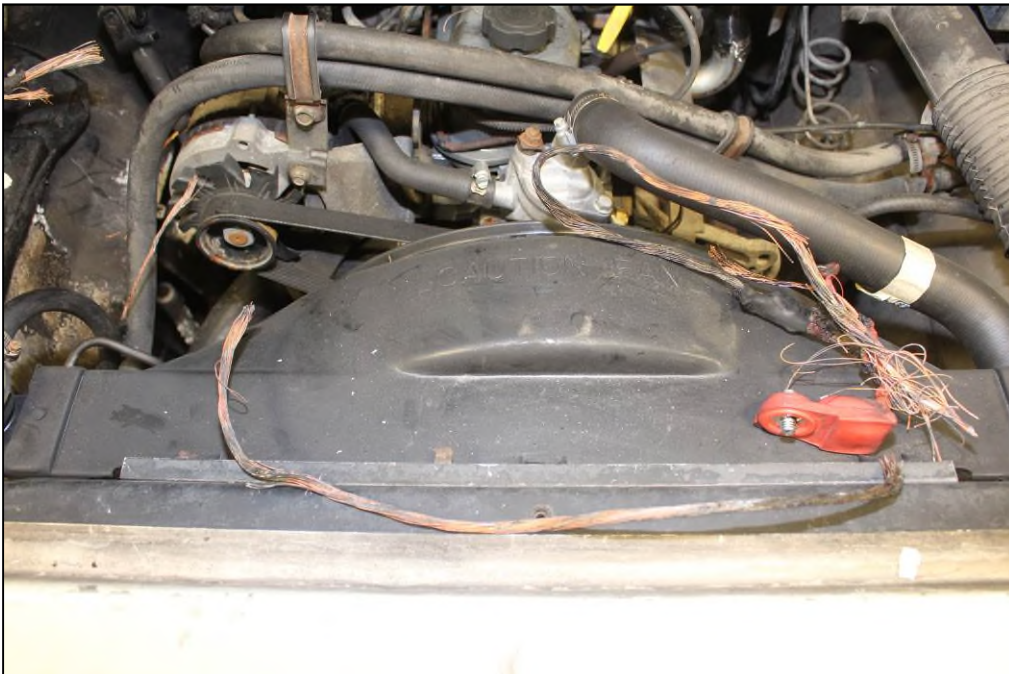
Photograph 2

Positive battery cable lying in the engine compartment.

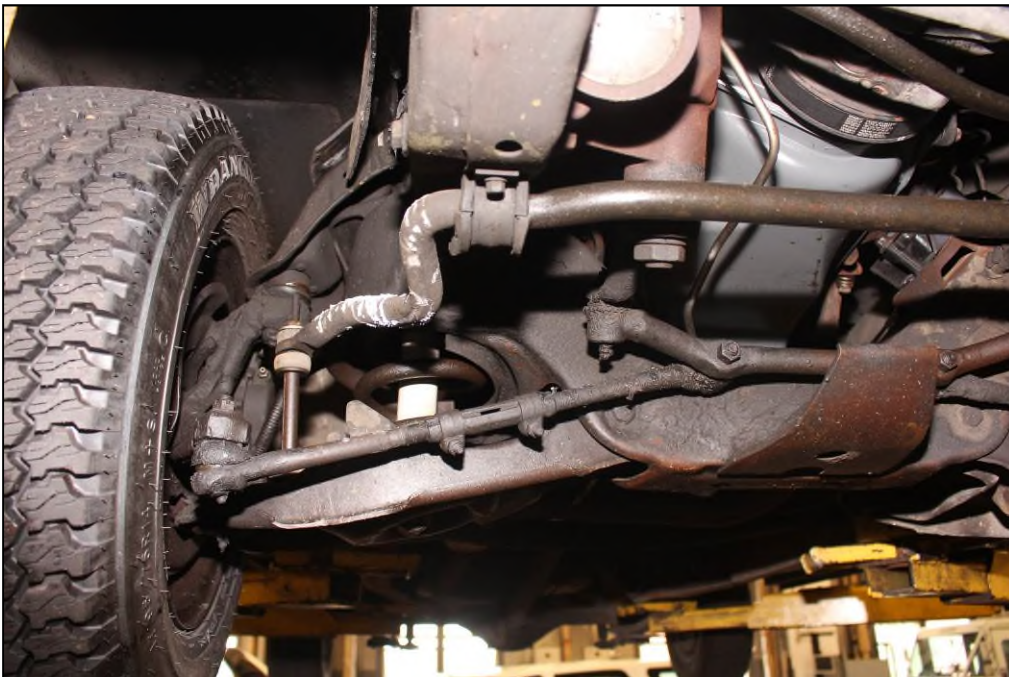
Photograph 4

View of the front right wheel and undercarriage. Accumulation of oil and road debris along the frame.

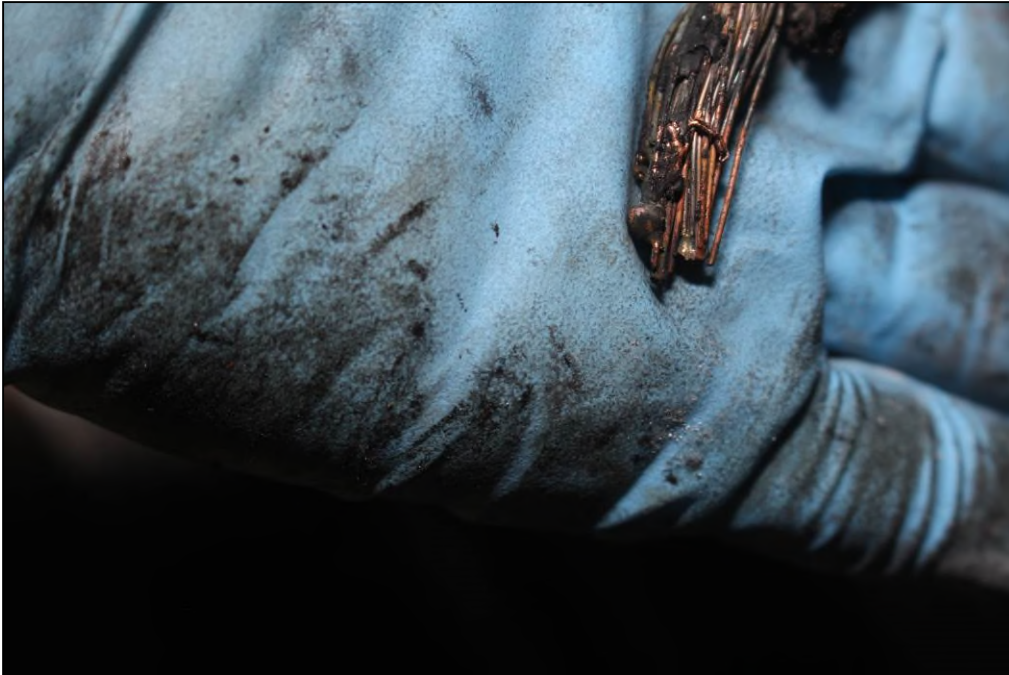
Photograph 5

Arc damage on the severed end of the positive starter cable.
